RAILROAD AVENUE PHOTO LOG

**RIO TINTO
LEGACY MANAGEMENT**

SUTHERLANDS PHOTO LOG

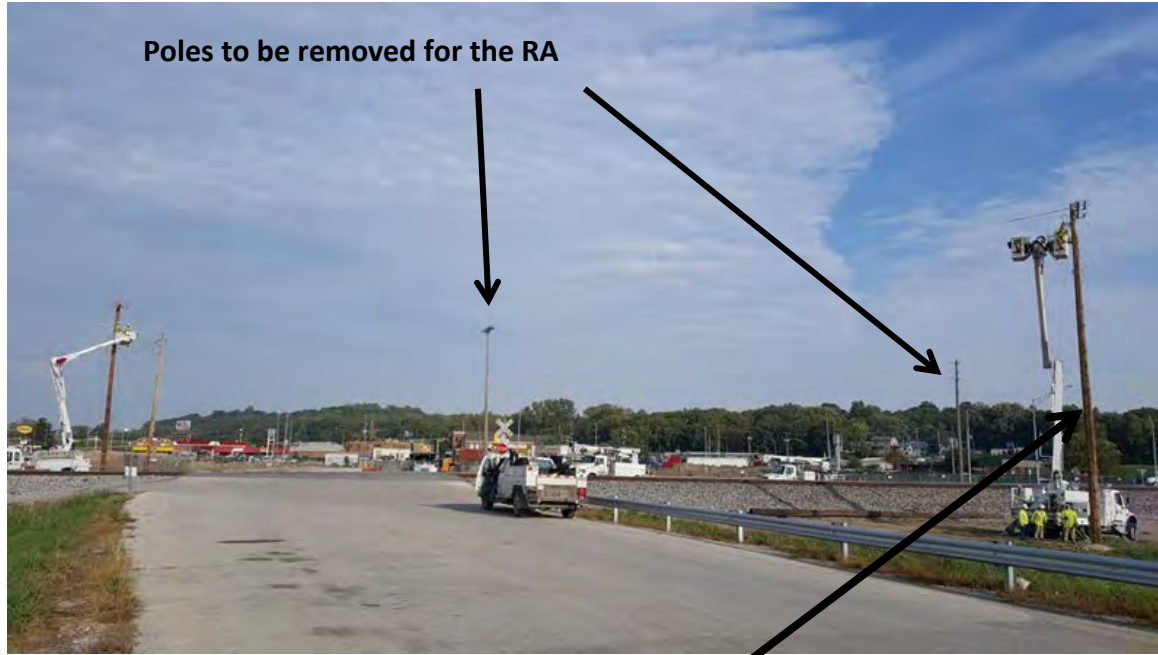
New power pole installed on NS property

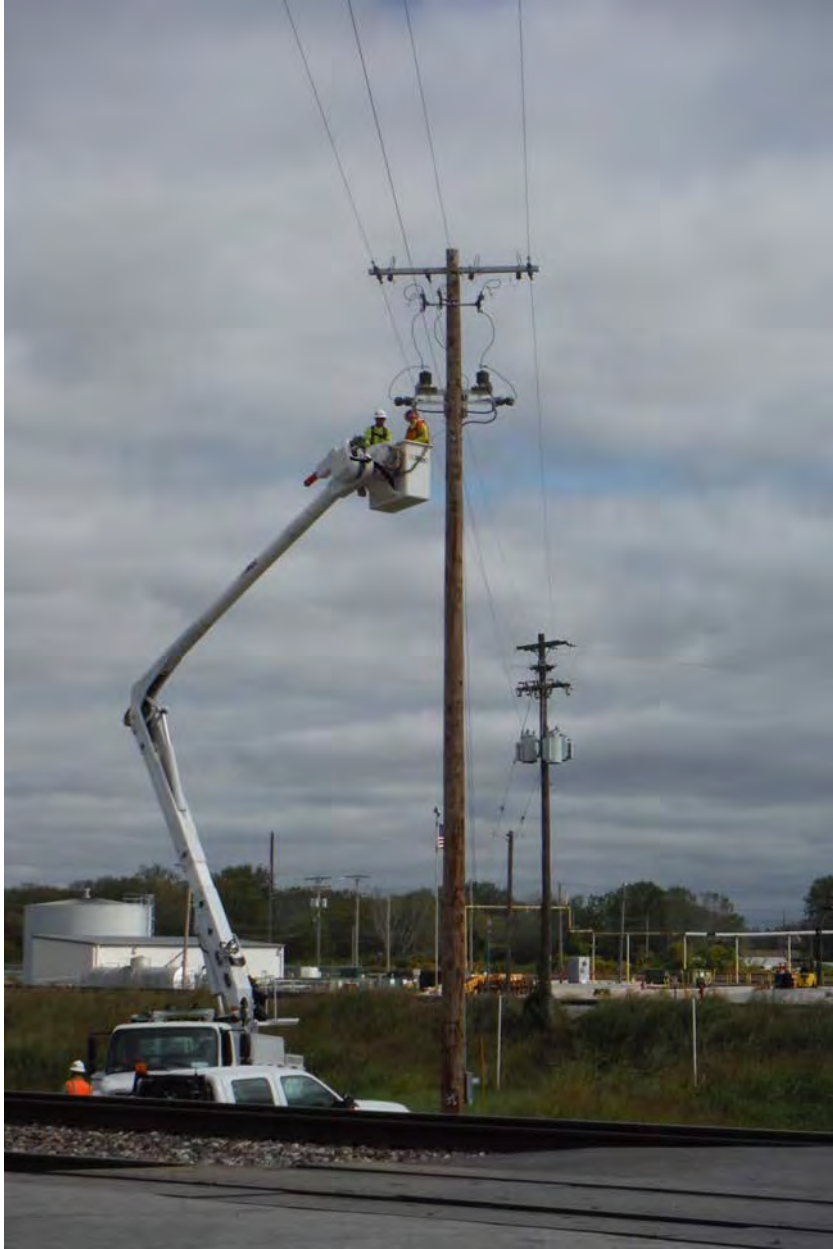
Stringing power to the NS Poles

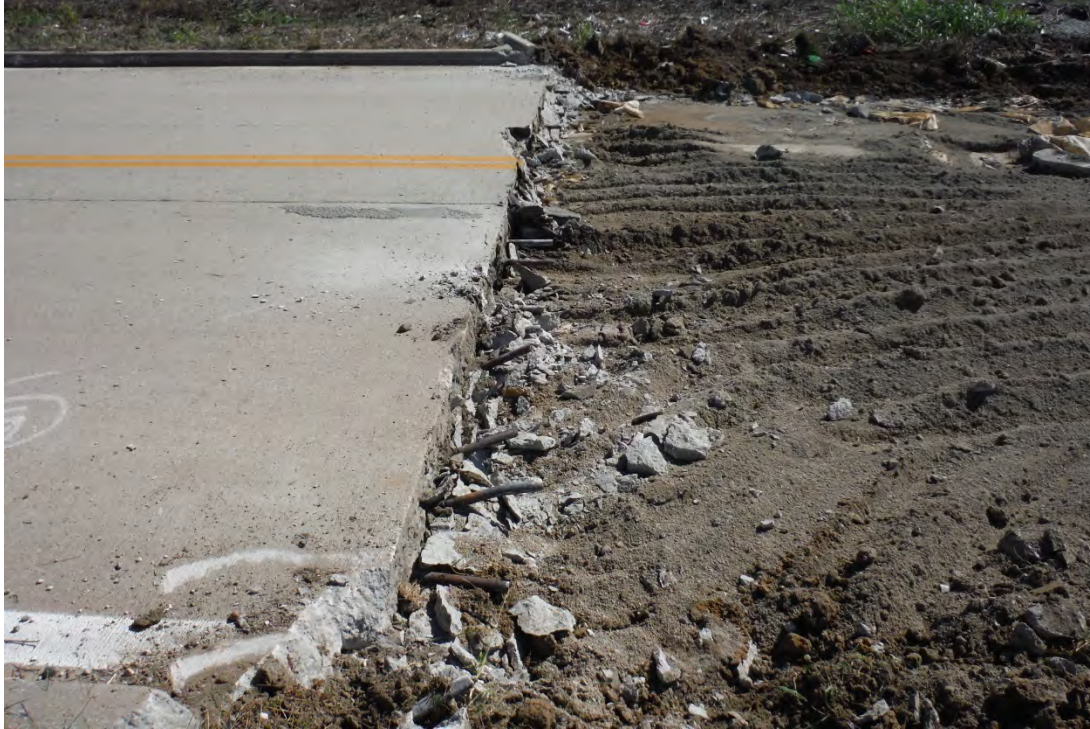
Cut RR Ave at the eastern most part of the RR Ave RA

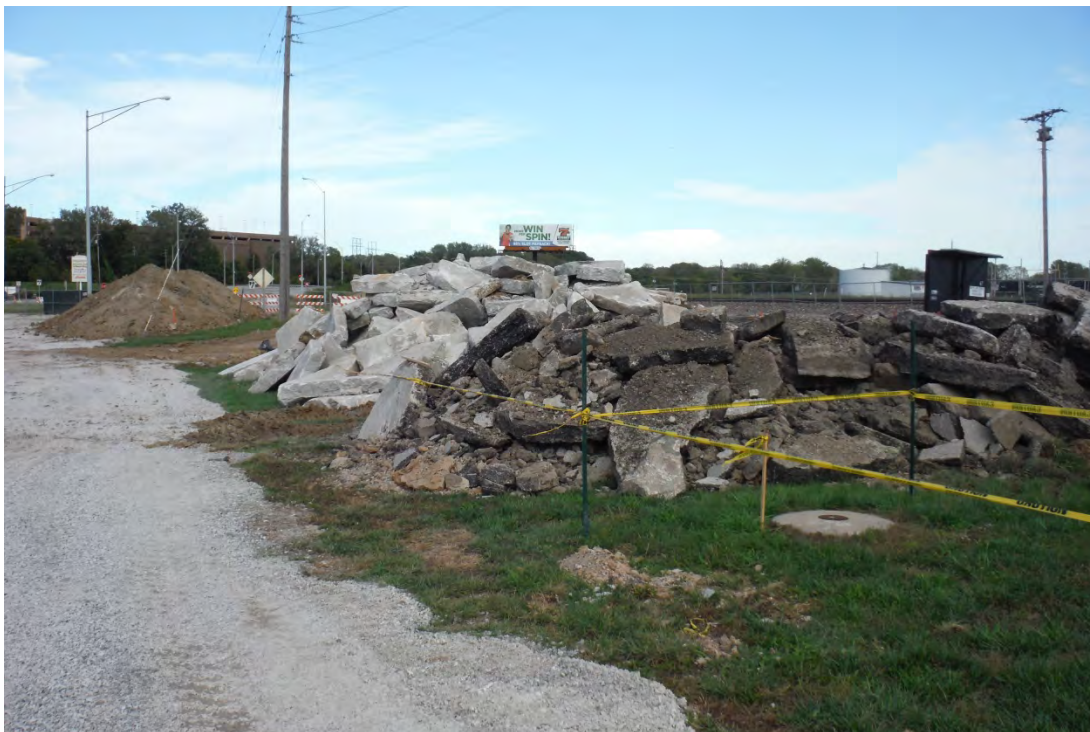
RR Ave demolition ready for disposal

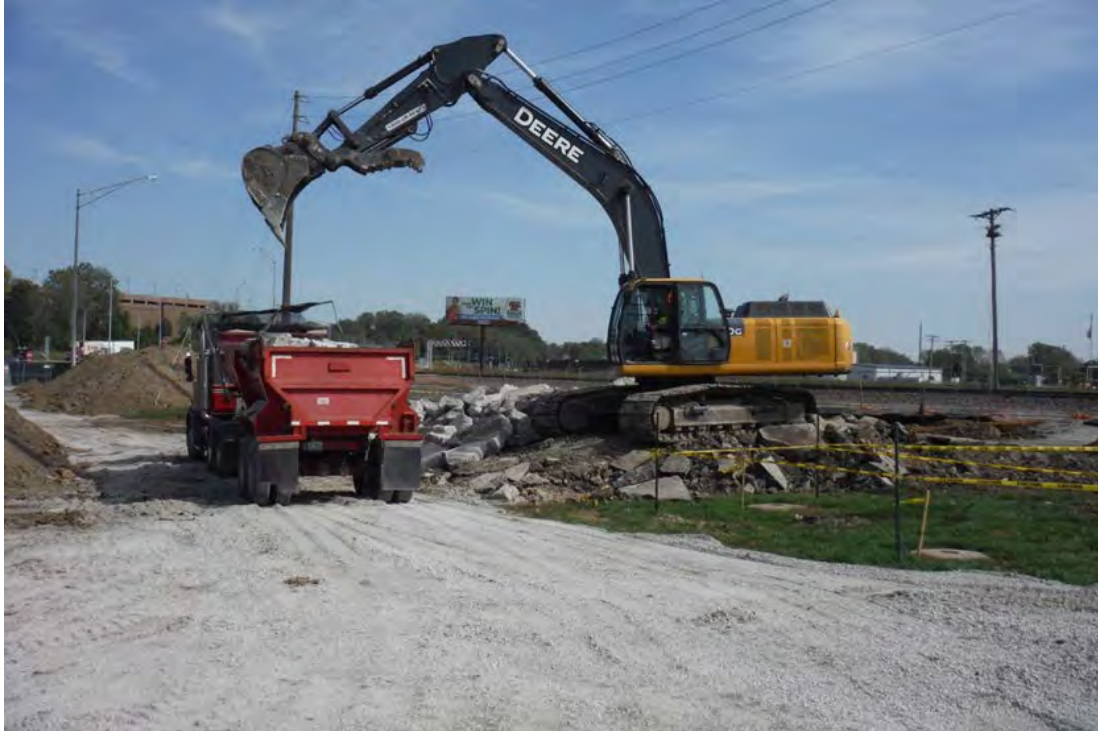
Demolition debris being loaded for off-haul

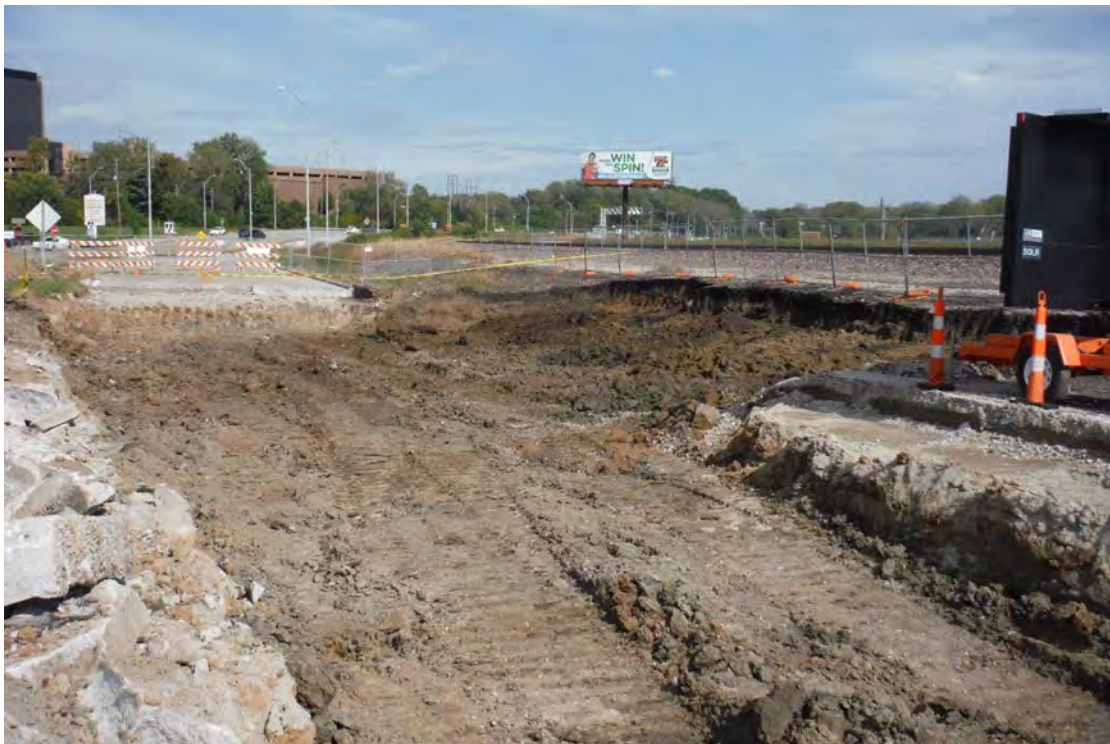
Initial RR Ave cut, eastern most area

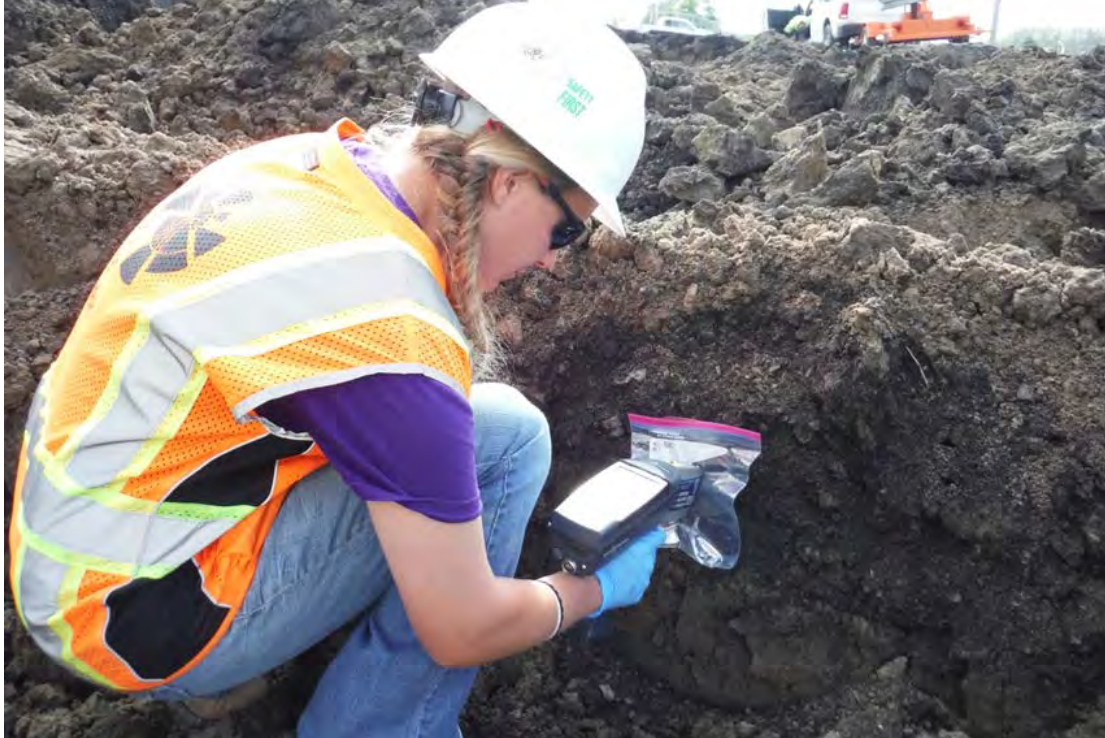
In-situ field testing with the XRF

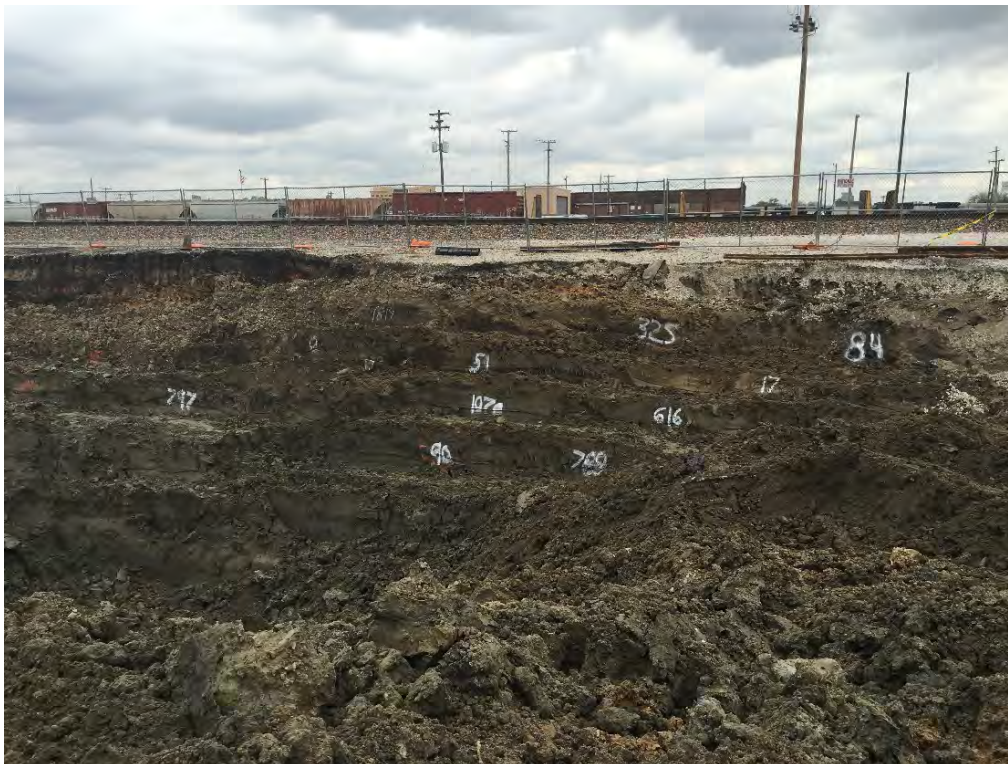
RR Ave south wall. Painted numbers are arsenic concentrations

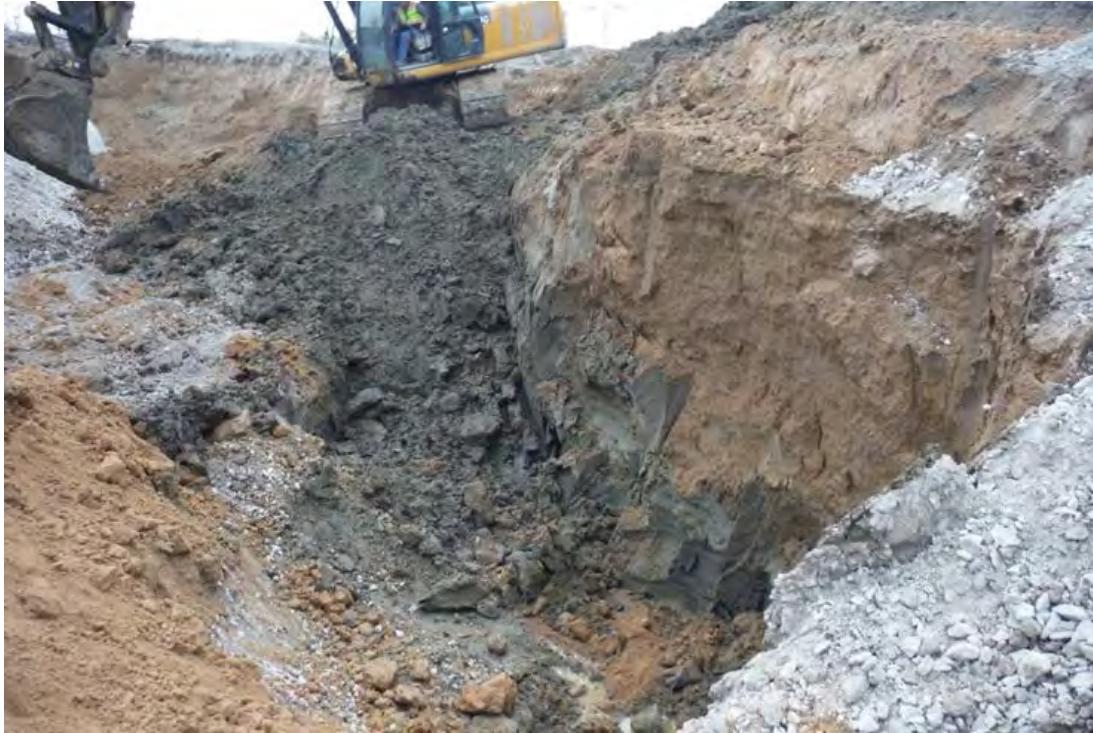
North wall showing brown loess backfill from the 2006 RA

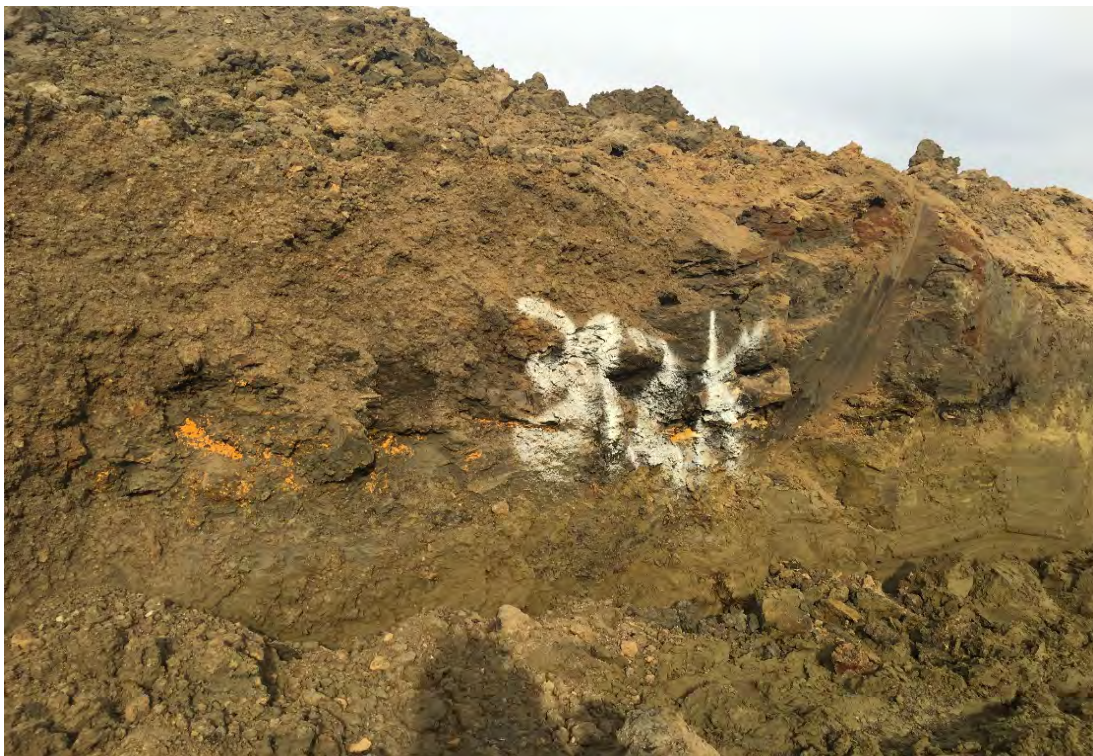
38,200 mg/kg arsenic south sidewall. Contamination was removed.

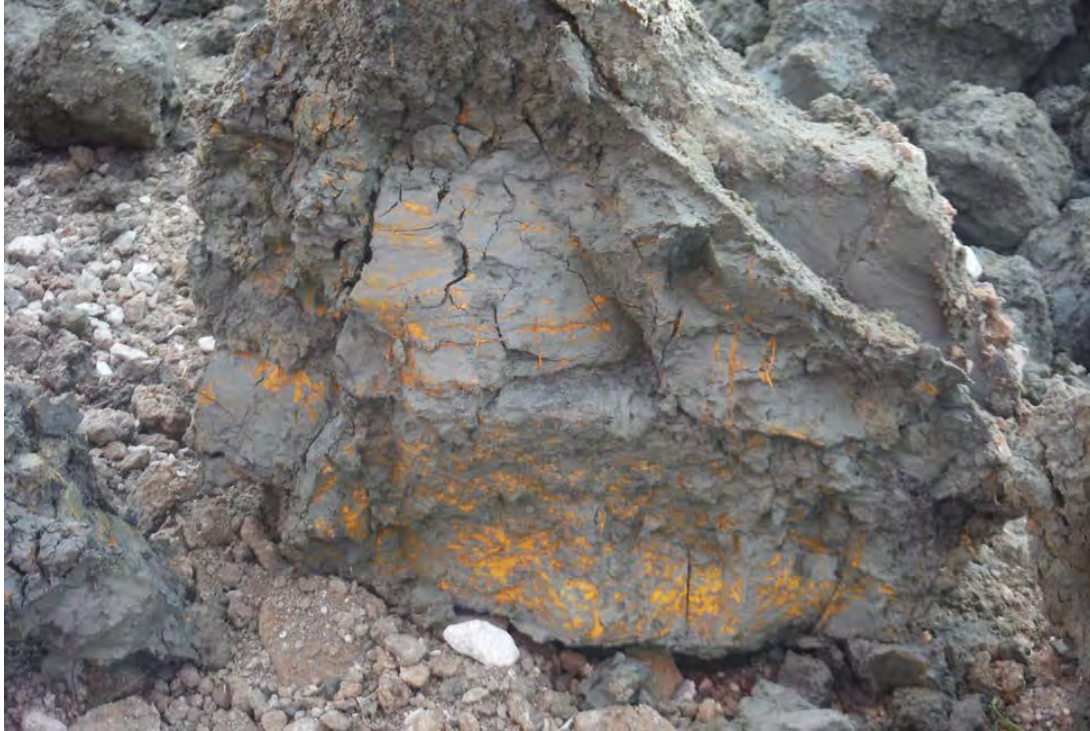
Distinctive yellow/orange color of arsenic contamination

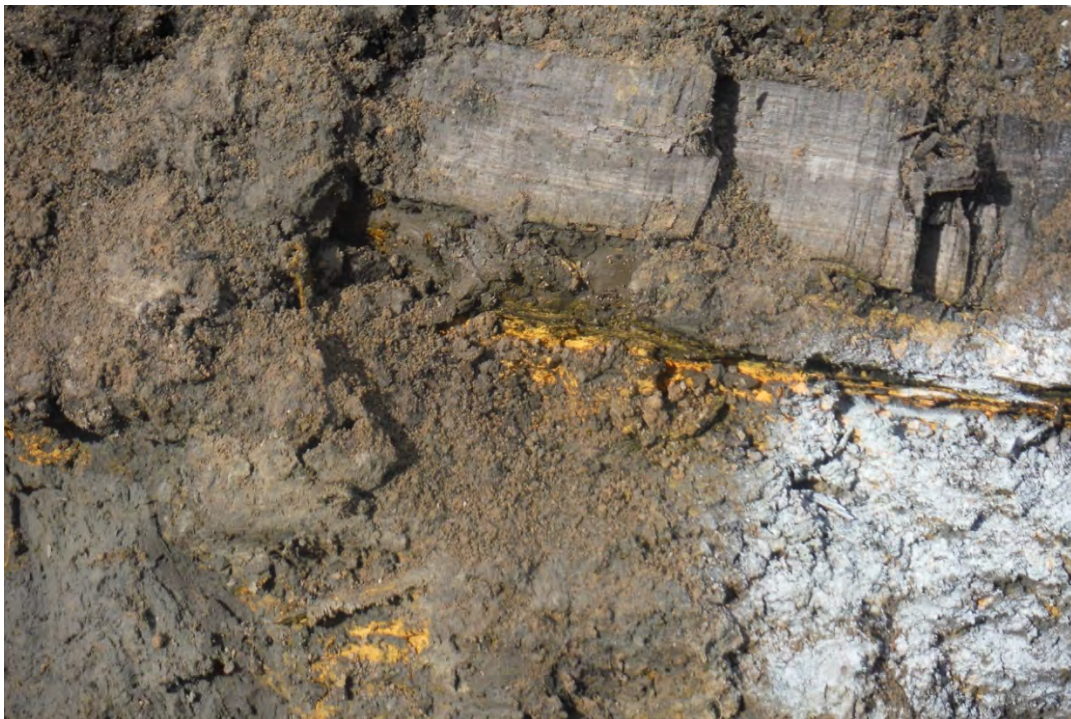
Distinctive area treated in-situ.

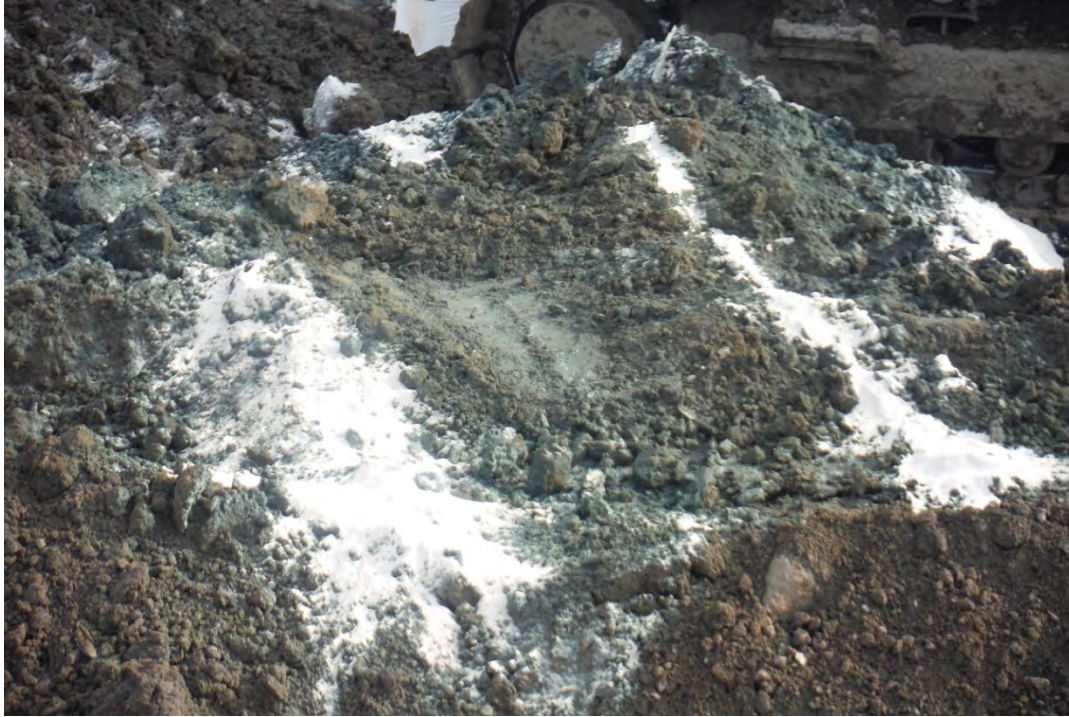
In-situ placement and mixing of Enviroblend

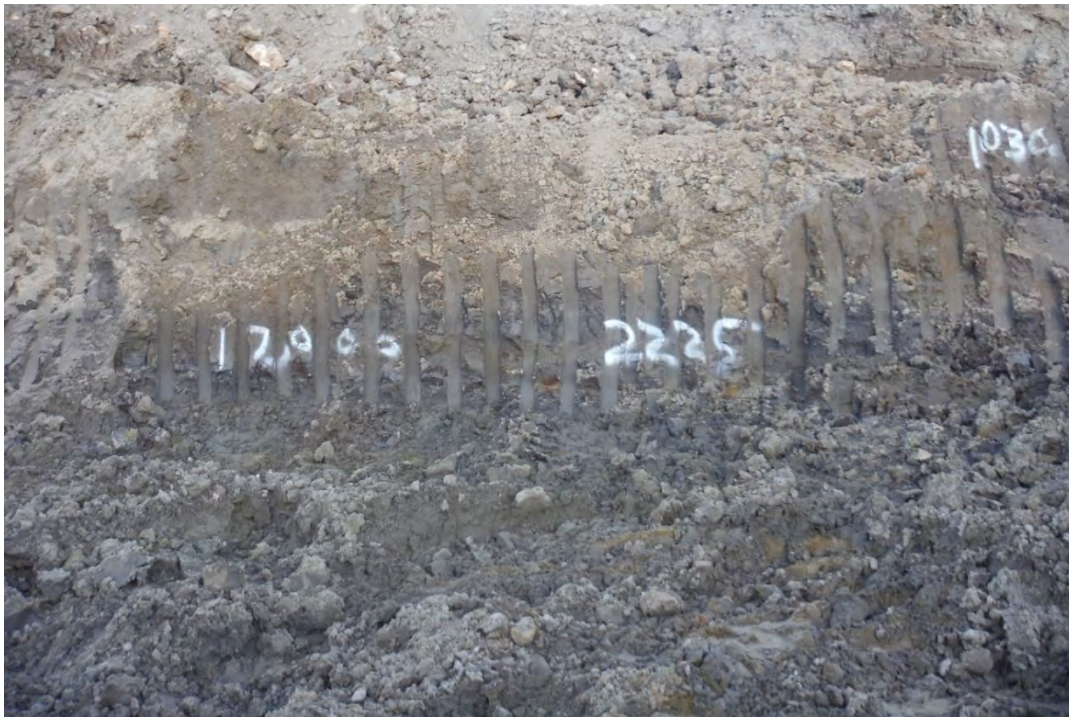
Highly variable arsenic concentrations along the north sidewall. All removed

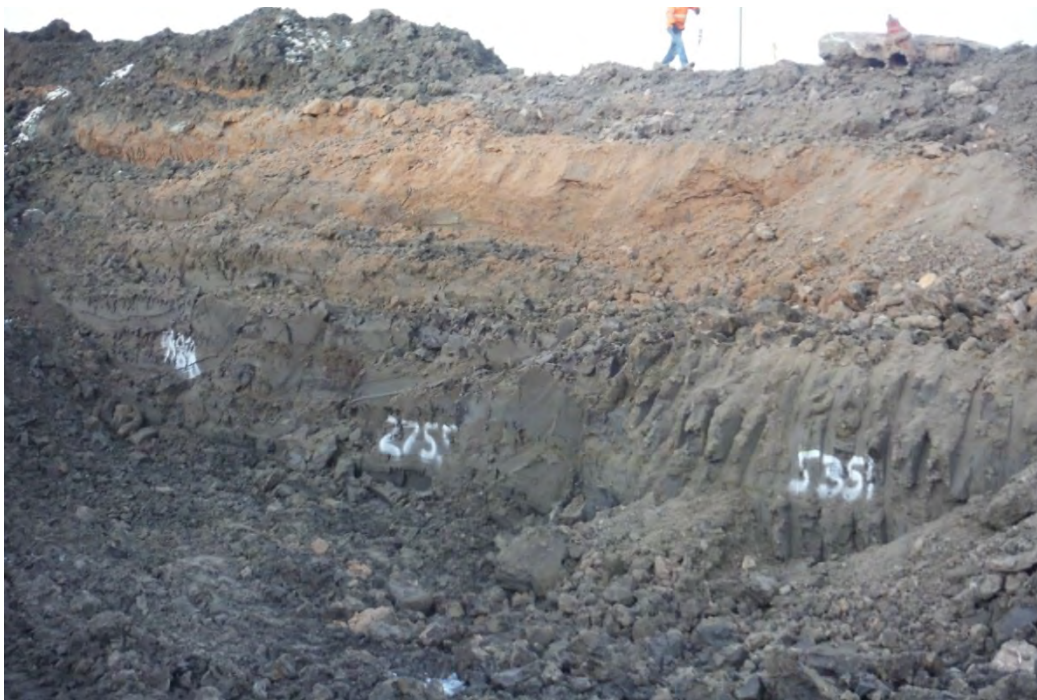
North wall showing the brown loess from the 2006 RA overlying contamination that was removed during the 2016 RA

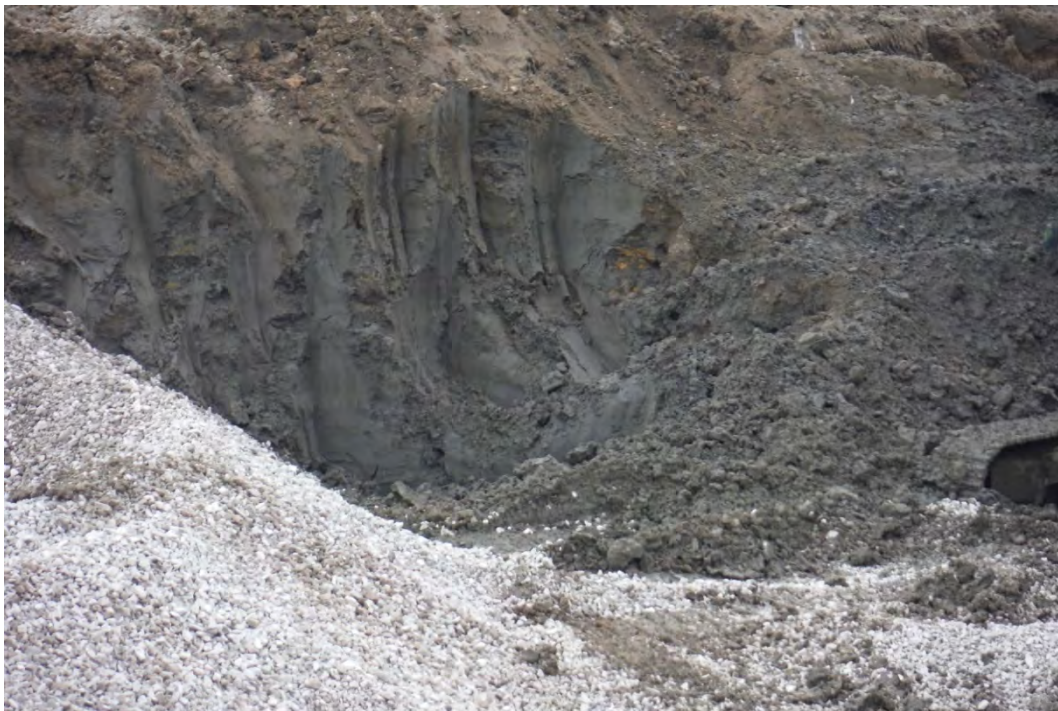
**Slot cut trenching along the south wall to remove additional arsenic mass.
Gravel is bridging backfill**

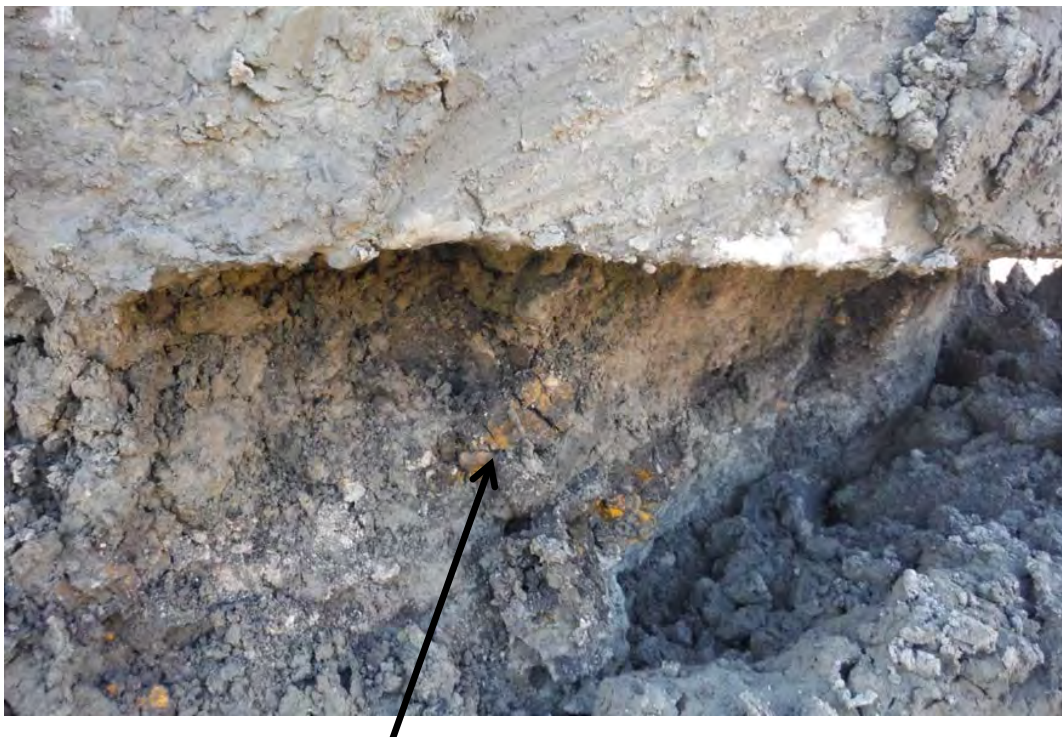
Arsenic under the sump (yellow)

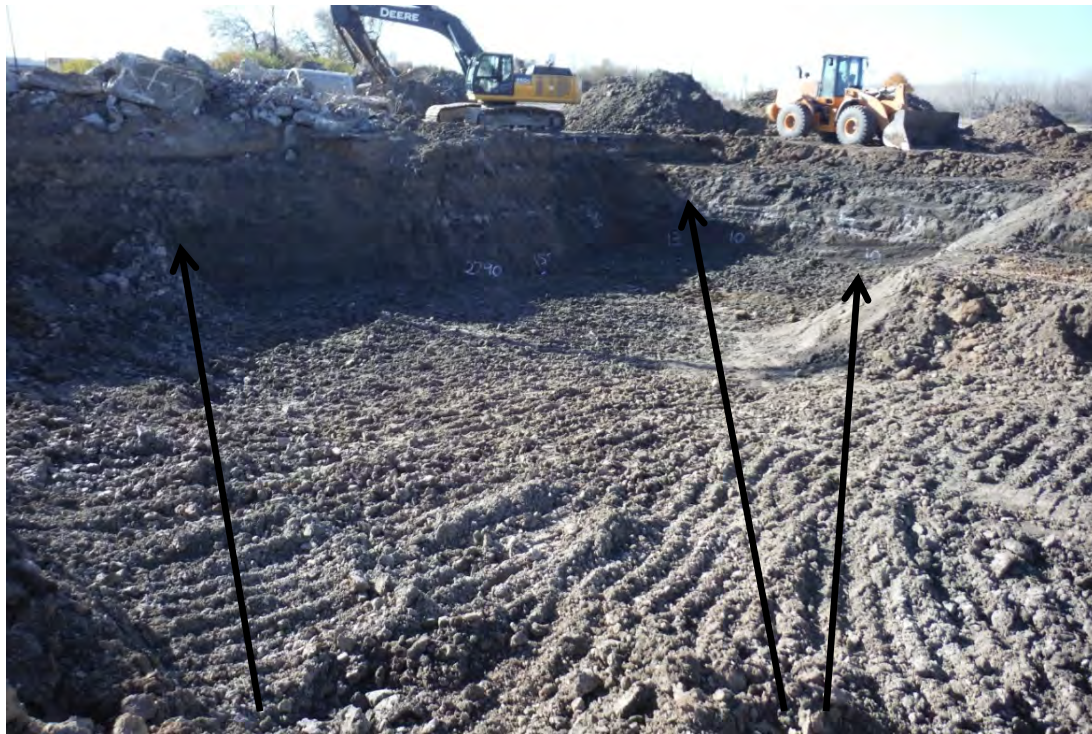
Sump gone Contaminated soil

Clean

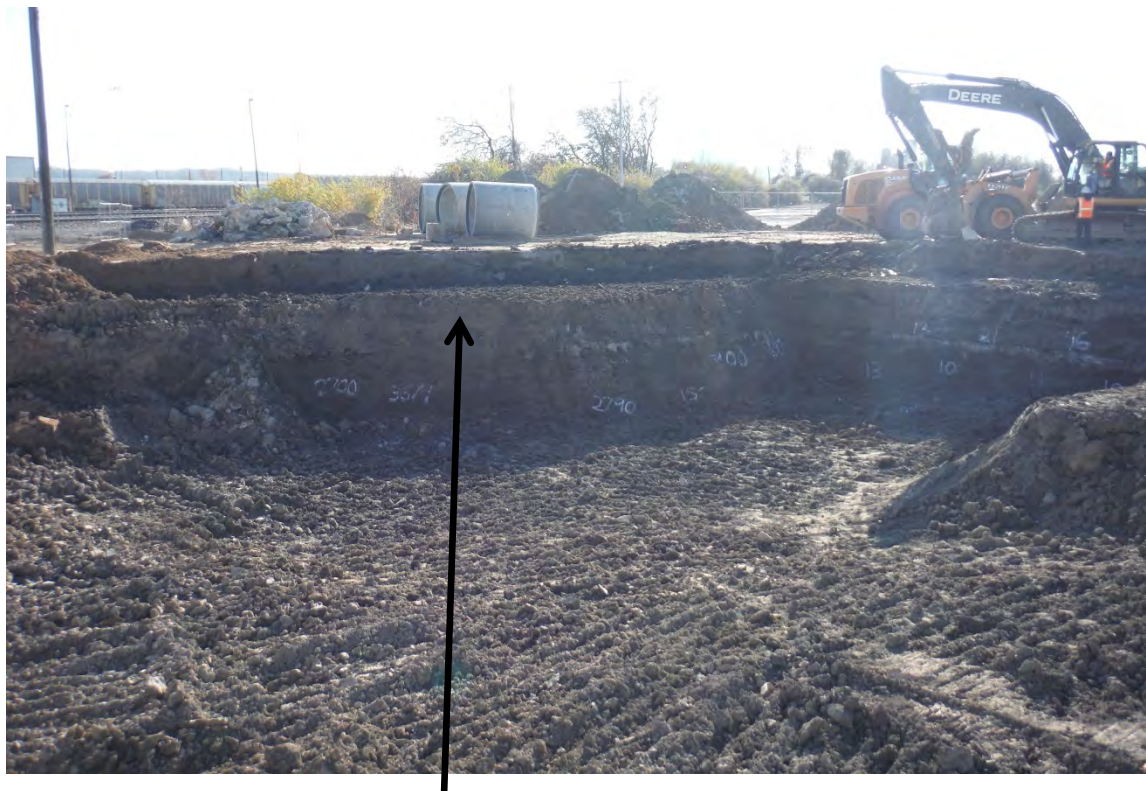
Excavation continues south to remove contaminated southern wall (exceeds 3,500 mg/kg)

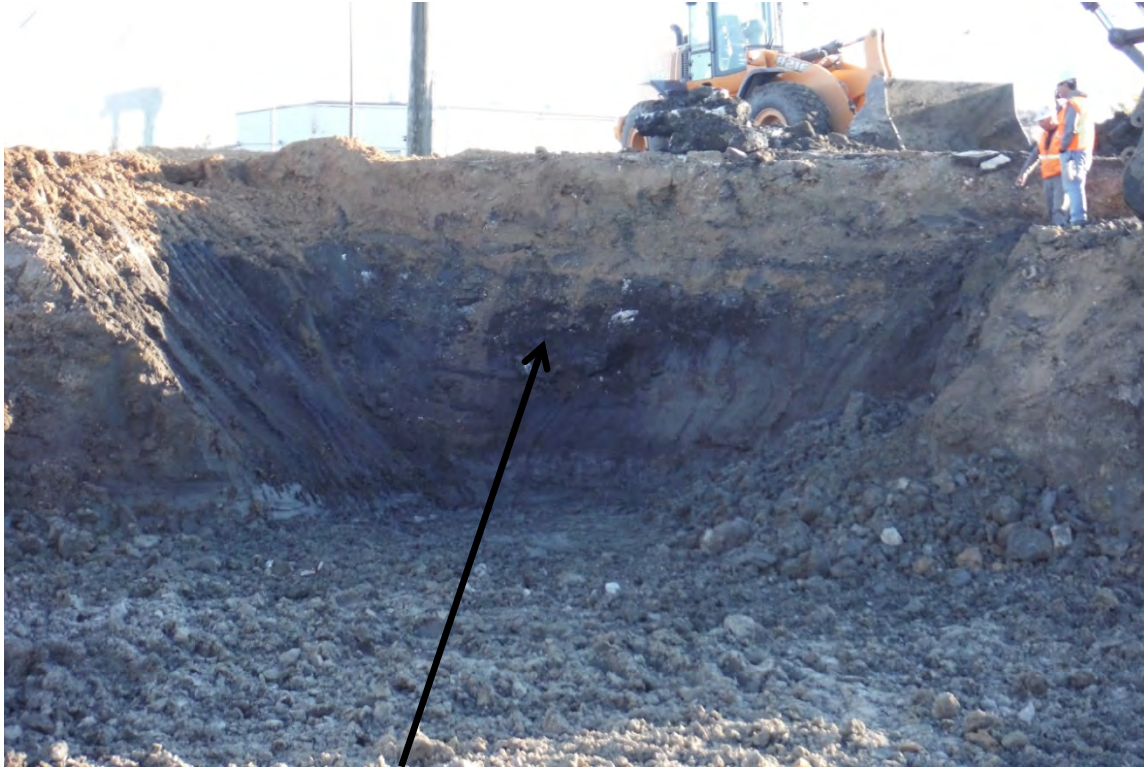
Excavation to the south, high contamination at sump elevation

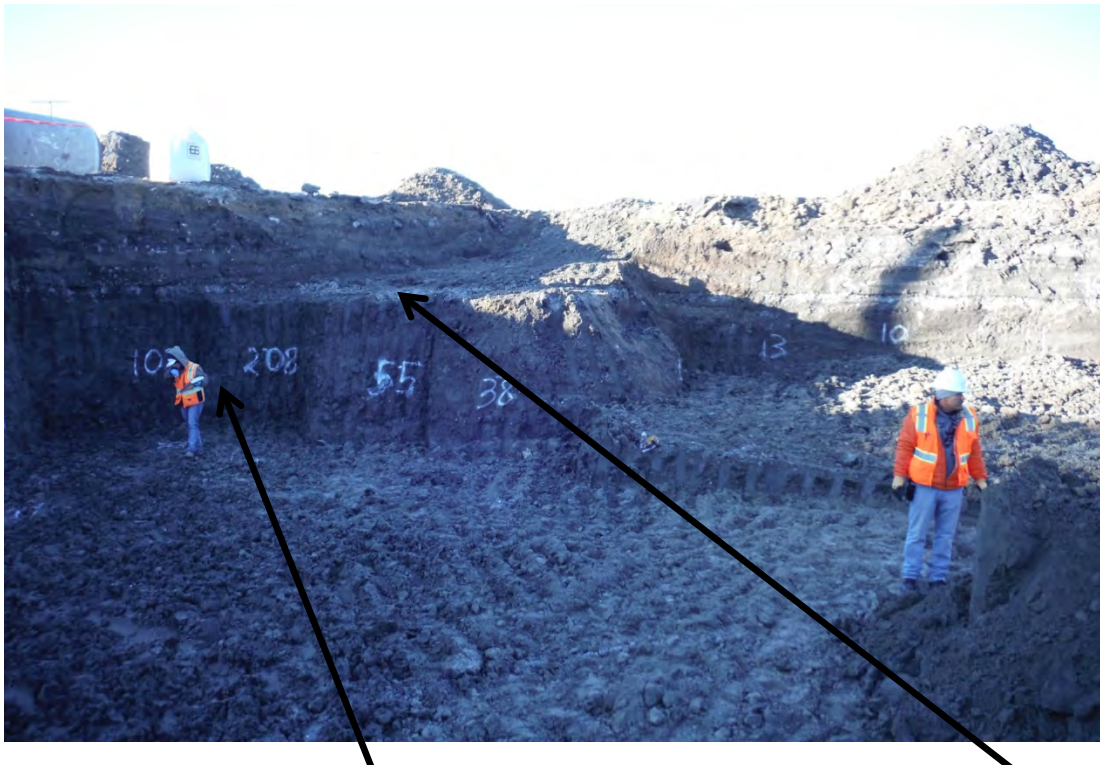
Sump area cut to the south and deep, upper bench is sump elevation. Former land surface highly contaminated.

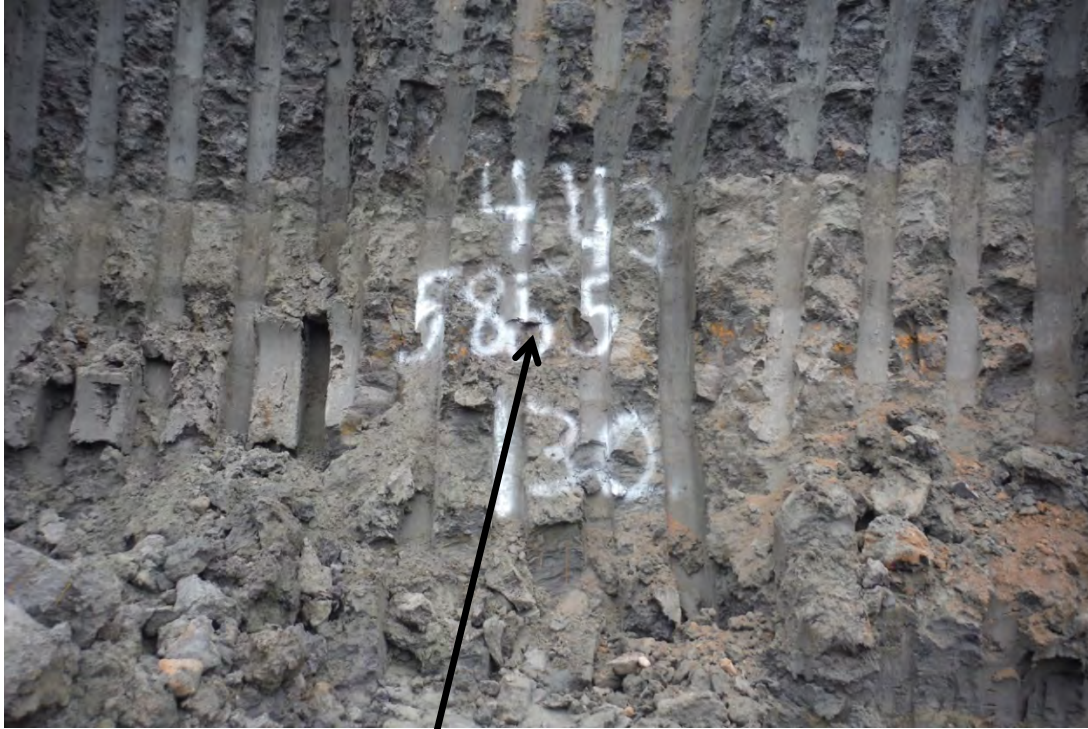
Sidewall south of the Sump shows lateral arsenic migration at the sump elevation and much lower arsenic concentrations in surrounding soil

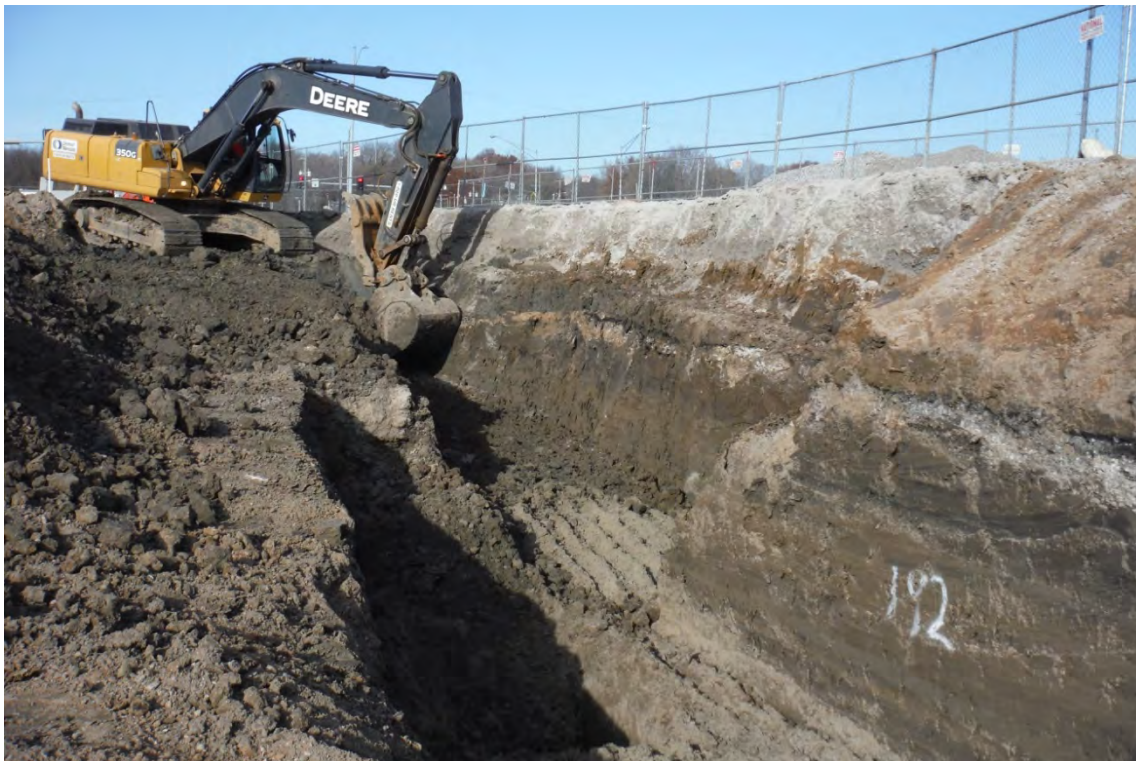
East wall along HABCO property line, much lower arsenic contamination than in sump area

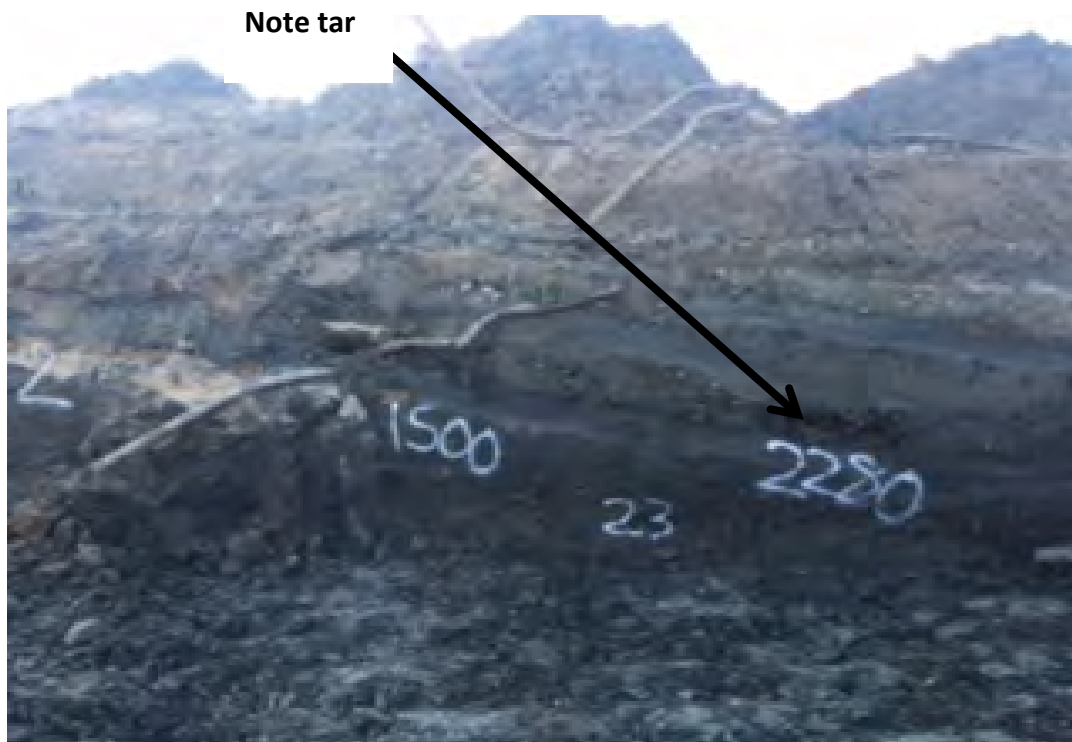
Sutherland's area to the north nearing old building piles, underground plumbing; increasing contamination including tar.

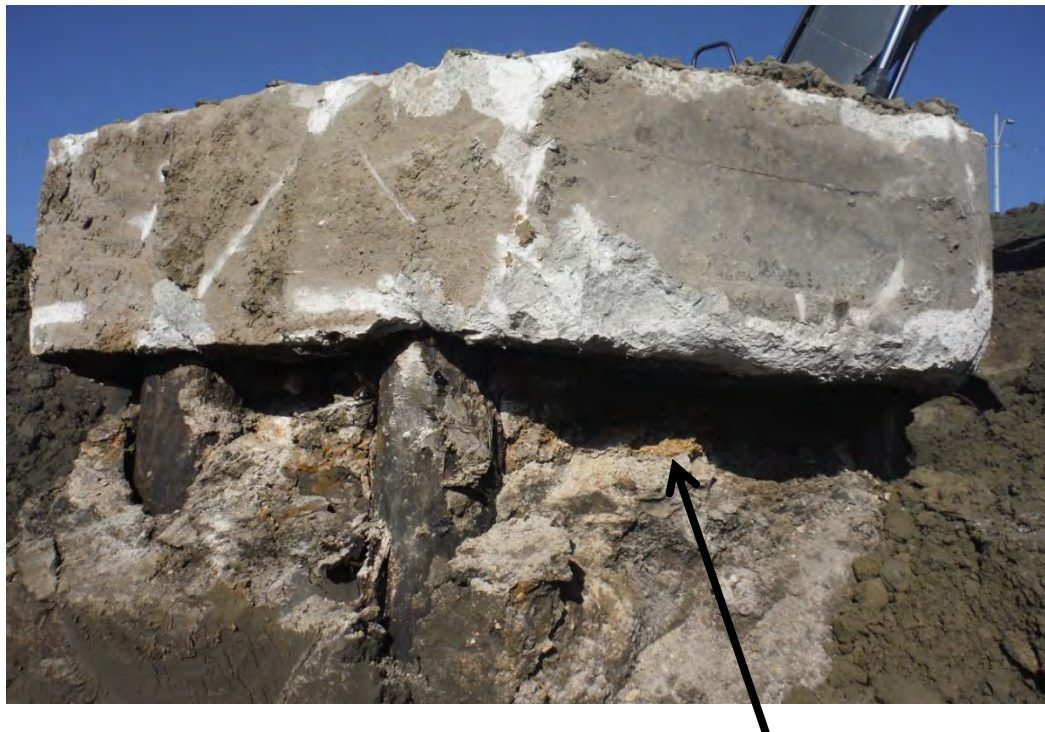
Six large concrete slabs found on piers. Arsenic contamination under the slabs

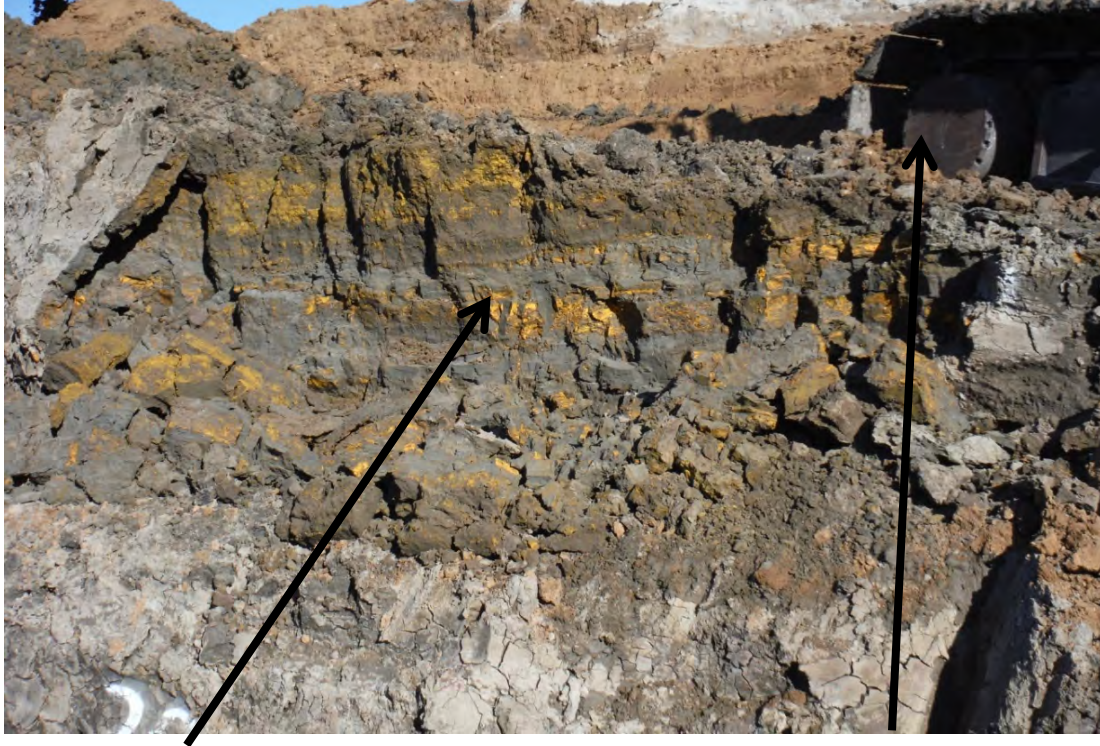
Arsenic around the slabs up to 24,000 mg/Kg

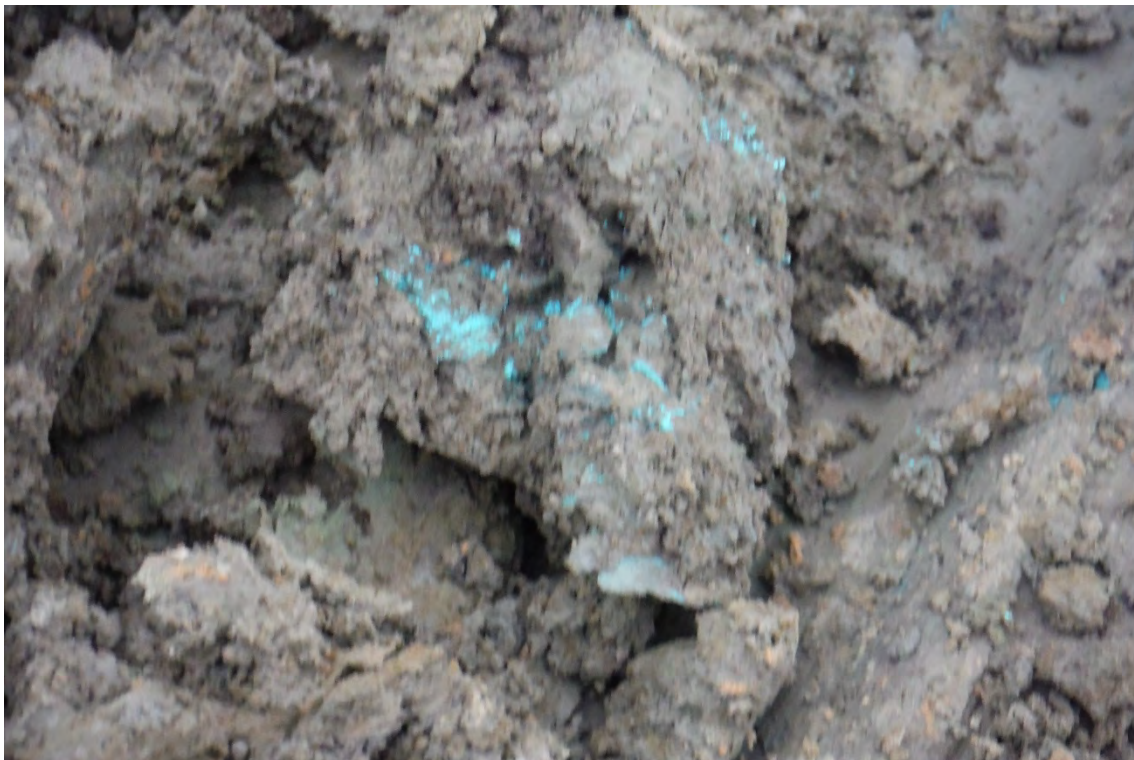
Copper contamination near the old foundations

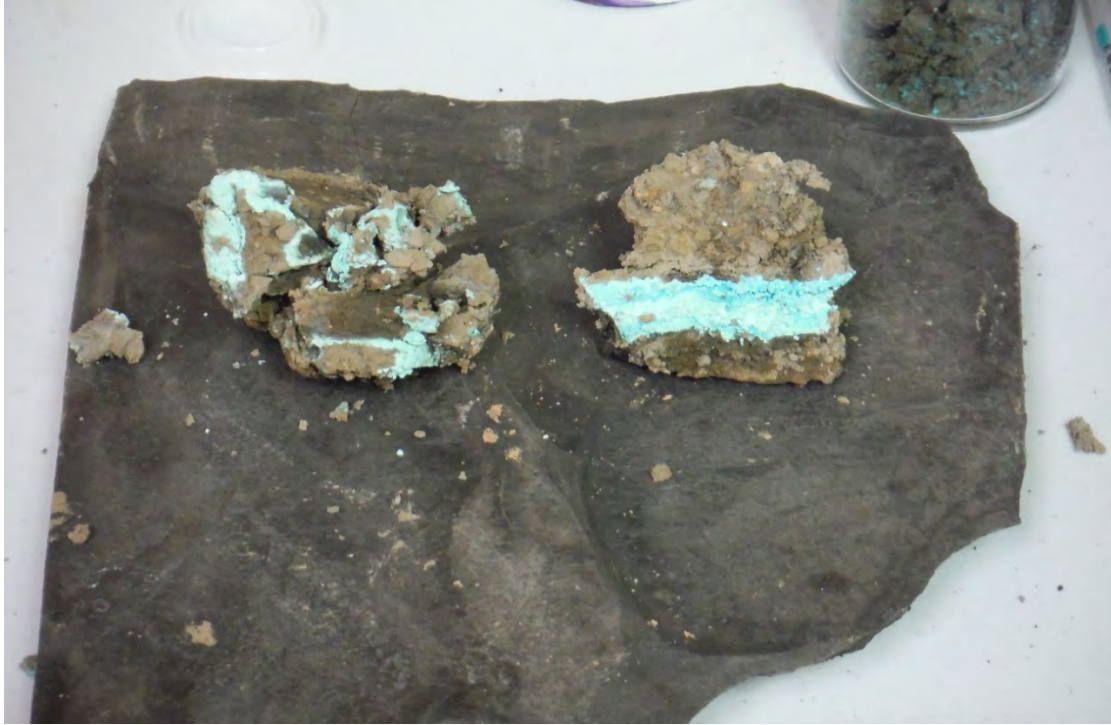
Samples of copper contamination
